# Tech Update

## NH3 Anhydrous Ammonia Permeation

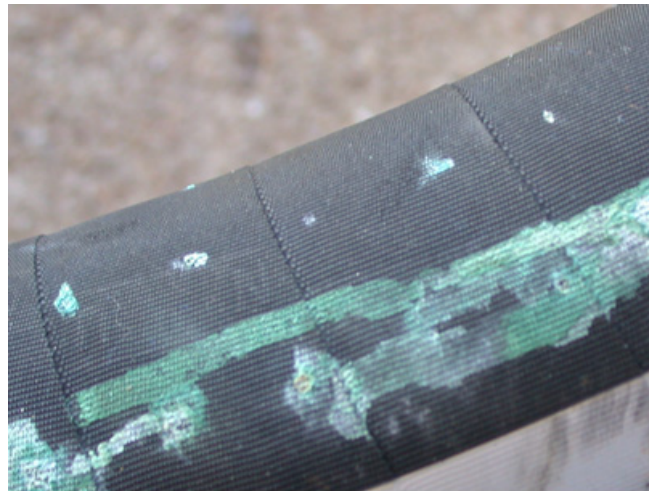
For this reason Parker perforates the cover of its' Anhydrous Ammonia hoses (Series 7261 and 7262). The pin-pricked holes allow a path for the gas to escape and greatly reduce the occurrence of cover blisters. However, as the gas escapes it may leave discoloration in the area of the pin-pricked holes.

It should be noted that staining of the hose in the pin-pricked areas does not indicate leakage. However, a visible gas mist escaping through the hose is an indication of leakage. To verify the integrity of a suspect hose assembly, a hydrostatic test can be performed at 200% of the hose maximum rated working pressure. Leakage at this pressure would indicate assembly failure.

Care should be taken to set up a test program for the periodic testing of Anhydrous Ammonia hoses. This will insure the integrity of the hose and hose assemblies. The RMA IP-11-2 publication on the Maintenance, Testing and Inspection of Anhydrous Ammonia hose is an excellent source for establishing these test criteria.
